By Tim Birnie

Common Electrical Hazards in Older Homes

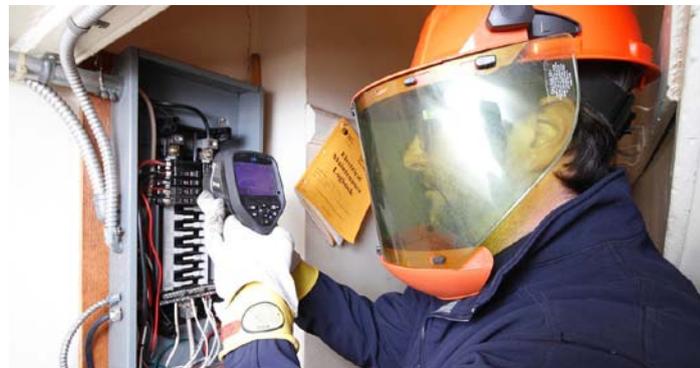
Innovative technology, like speciality infrared scanners, is used to inspect the electrical panel in older homes.
